UM-3736-98
1998 Acura Integra

In-depth Vehicle Occupant Report

The University
of Michigan
Transportation
Research Institute

Case Vehicle (A): 1998 Acura
 Type: Integra, 2-door coupe
 Driver: 20-year-old male
 CDC: 01-FDEW-2

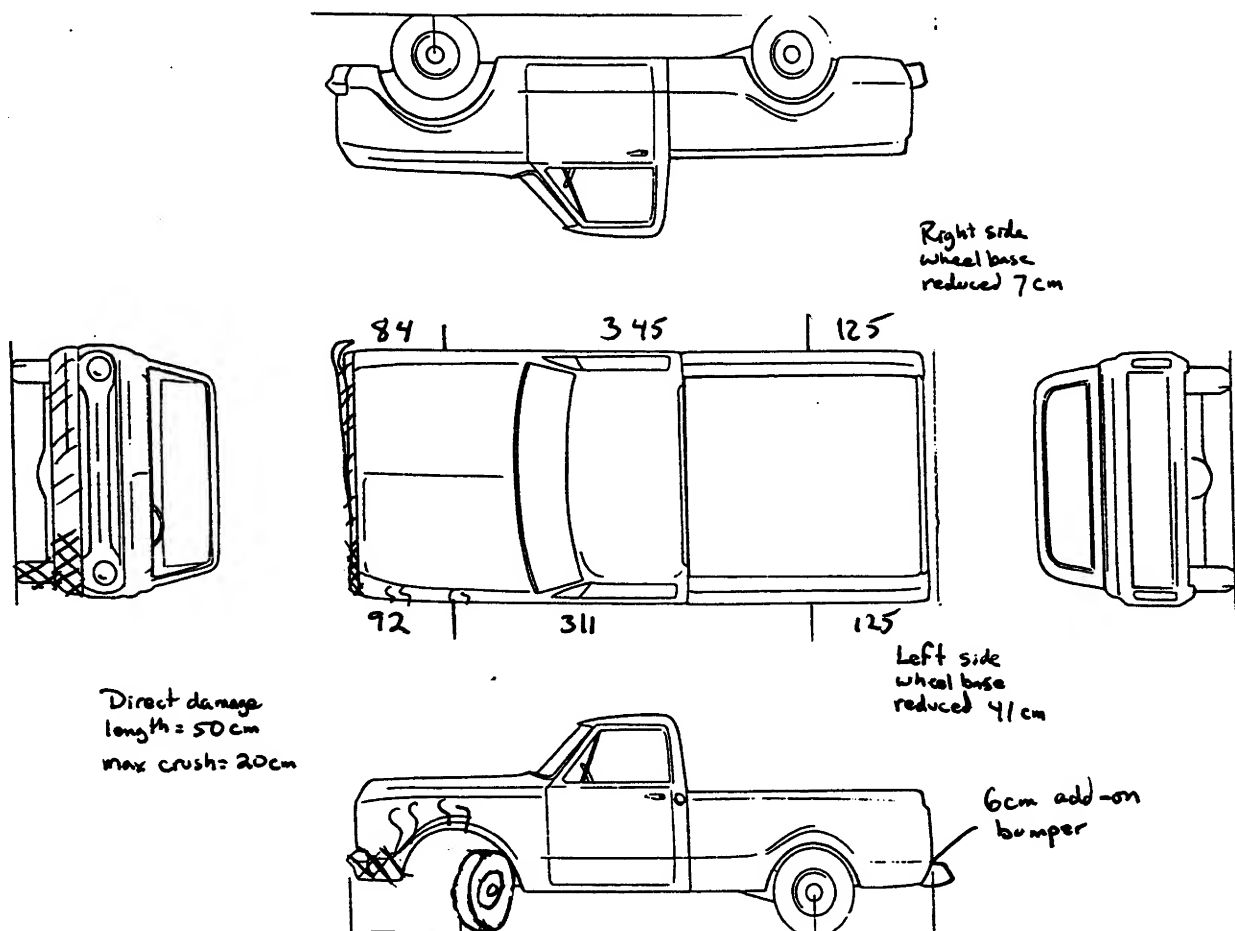
Damage to vehicle (B) was moderate. The direct damage length was 50 cm, and the maximum crush was 20 cm and occurred at the left-front bumper corner. The left-front wheel was displaced, reducing the wheelbase by 42 cm.

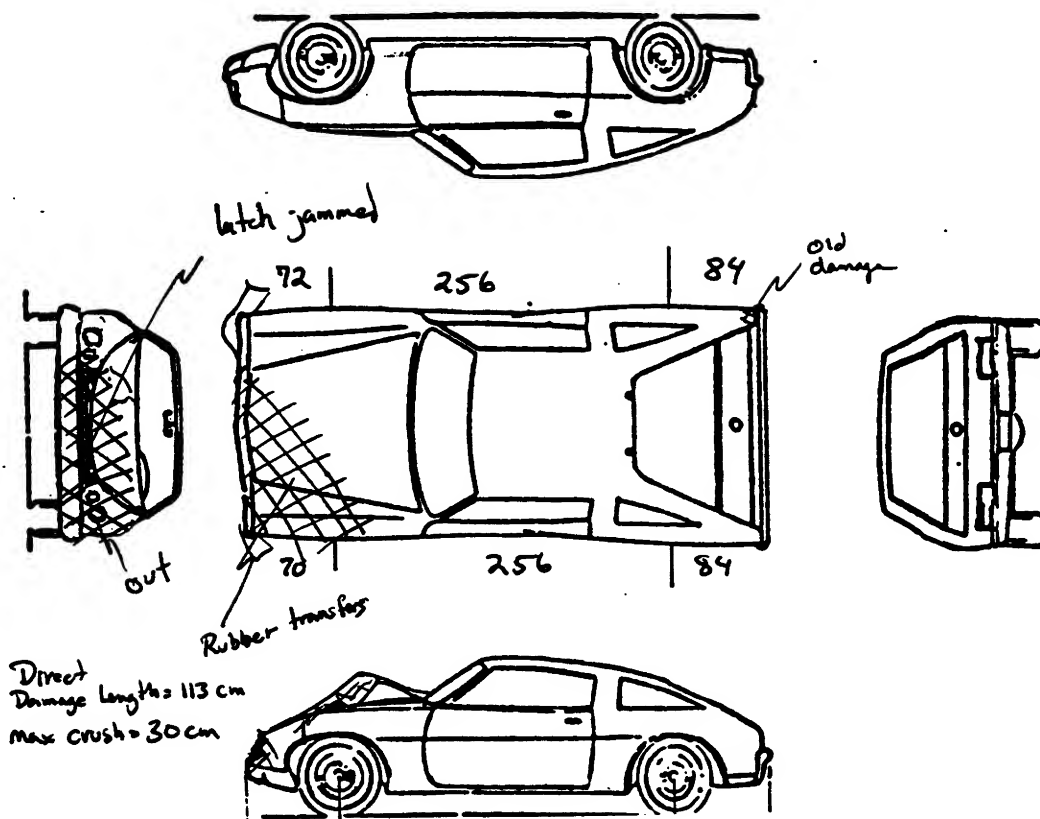
(Slides 13, 14, 15, 16) Damage to case vehicle (A) was moderate. Direct-damage length was 113 cm and began at the left-front bumper corner. Maximum crush was 30 cm and occurred 68 cm inboard from the left-front bumper corner. The front bumper, headlight assemblies, radiator and both fenders were damaged. The hood was damaged, and the hood latch was jammed. Both hood hinges were damaged, and the left hood hinge was separated from the hood. The rear edge of the hood was elevated, but it did not contact the windshield. Both doors remained closed and operational. There was damage to the windshield from the stress of impact forces.

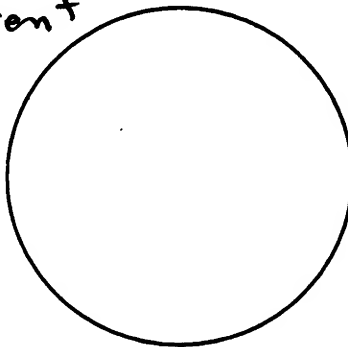
NOTE AND DESCRIBE ANY AIRBAG CONTACT OR
DAMAGE ON DIAGRAM BELOW:None
Apparent

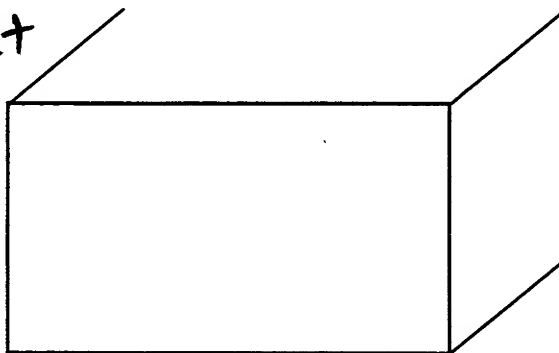
NOTE AND DESCRIBE ANY AIRBAG CONTACT OR
DAMAGE ON DIAGRAM BELOW:None
Apparent
